14th South East Asia Survey Congress (SEASC)
Brunei Darussalam in 2017

The Road from National LiDAR mapping program to Zonation of the Geologically Sensitive Areas in Taiwan

Li-Yuan FEI

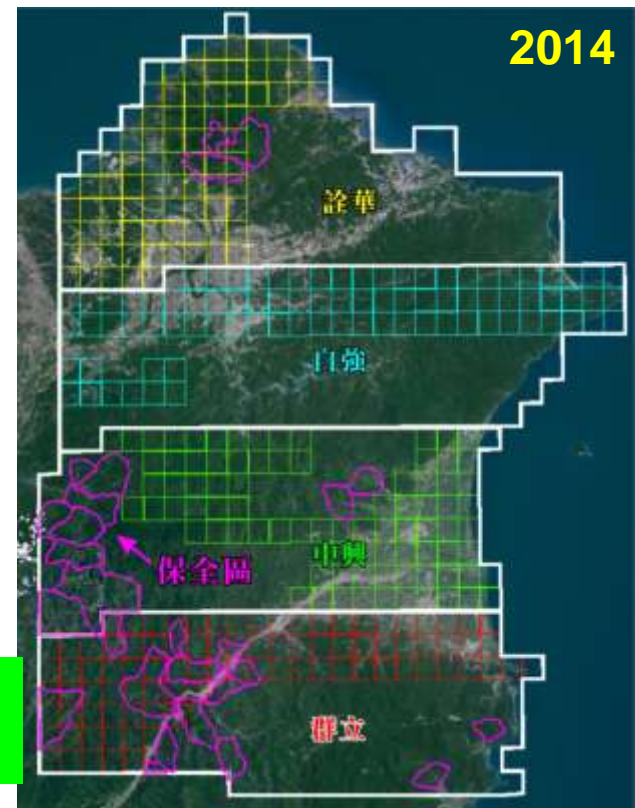
Protected areas (selected areas near mountainous settlements), need more denser flight strips, acquire more point cloud in the ground

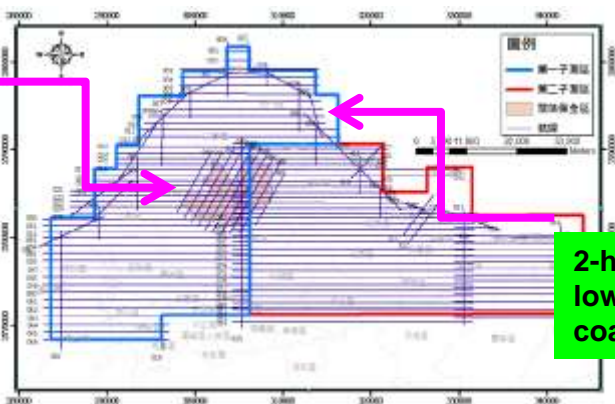
2-hour window for low-tide survey in coastal area

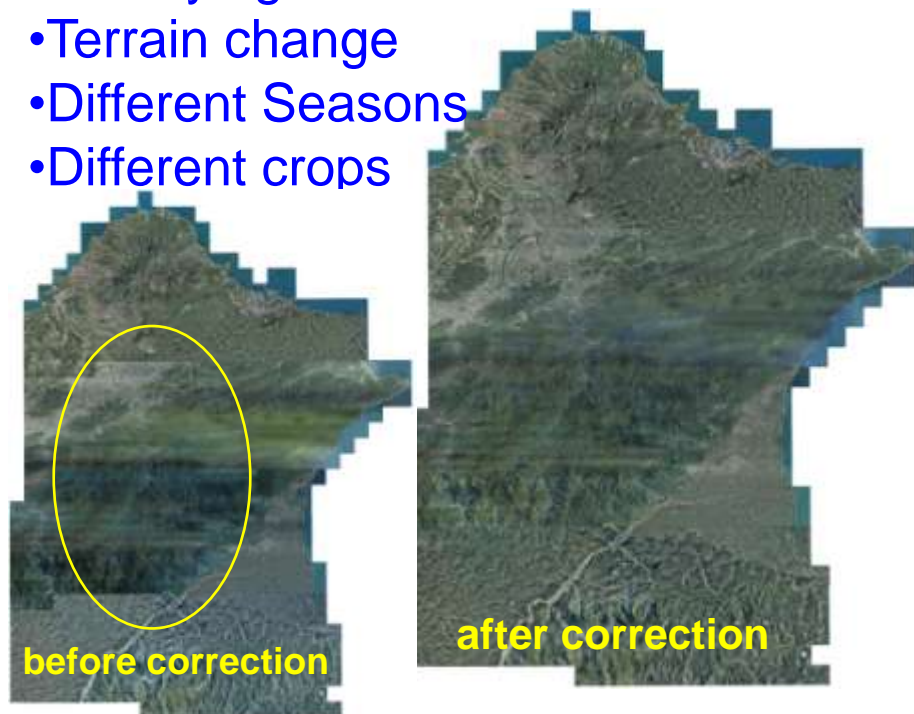
Using standard orthoimages
Different color or tone of the aerial photographs

Edge discrepancies reasons :

- Different instruments
- Different measurement results
- Surveying at different times
- Terrain change
- Different Seasons
- Different crops

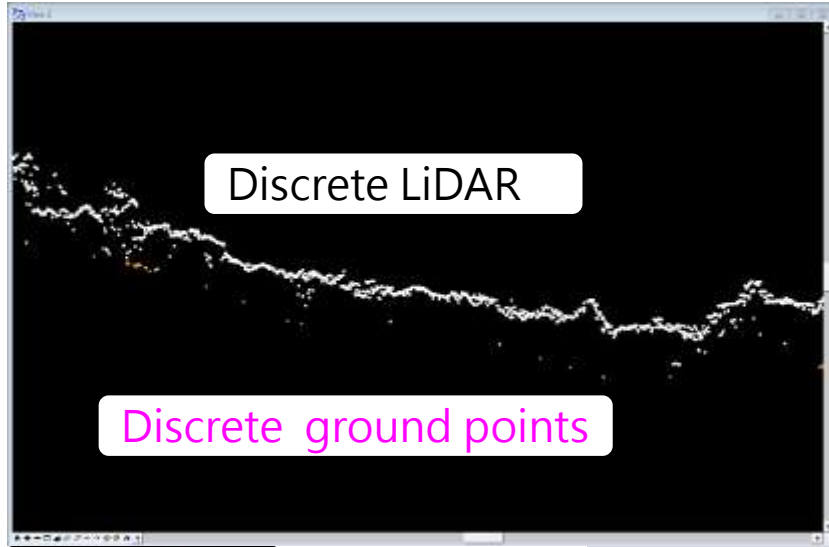
Improve the ground points under dense vegetation Using full-waveform LiDAR extraction technique

Discrete LiDAR's penetration was 9.98%.
After the full-waveform extraction, the penetration increased by 3.55%.

In the study area of very dense forest, full-waveform LiDAR can give ground points 34~35% more than discrete LiDAR.

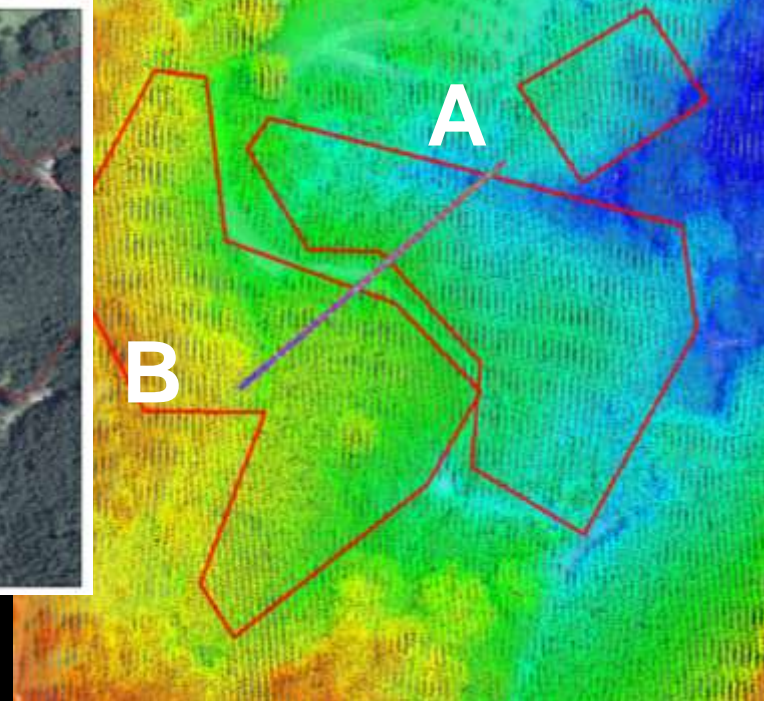
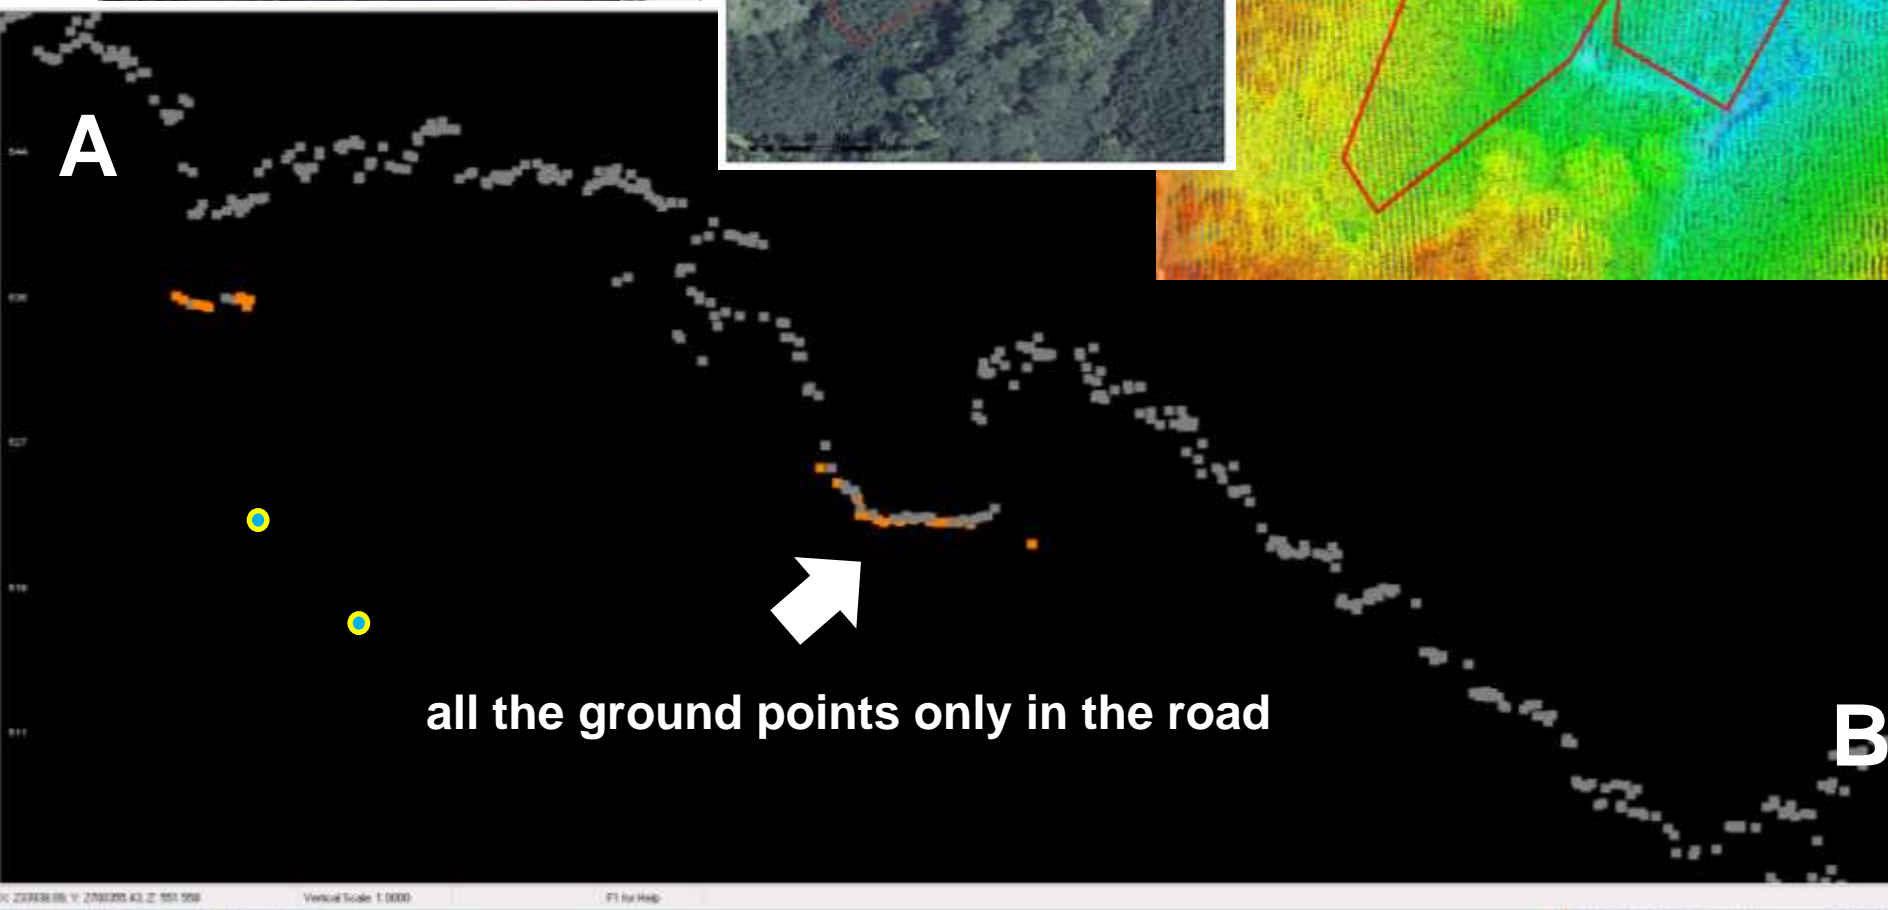
Discrete LiDAR
574,198 ground points

Discrete + full-waveform
778,297 ground points

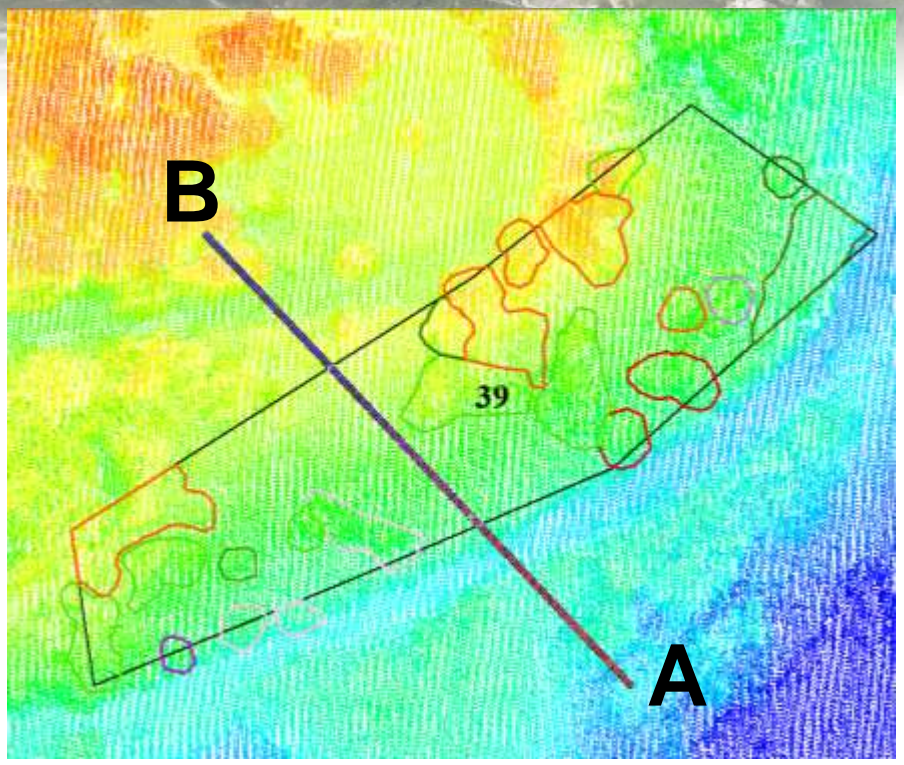
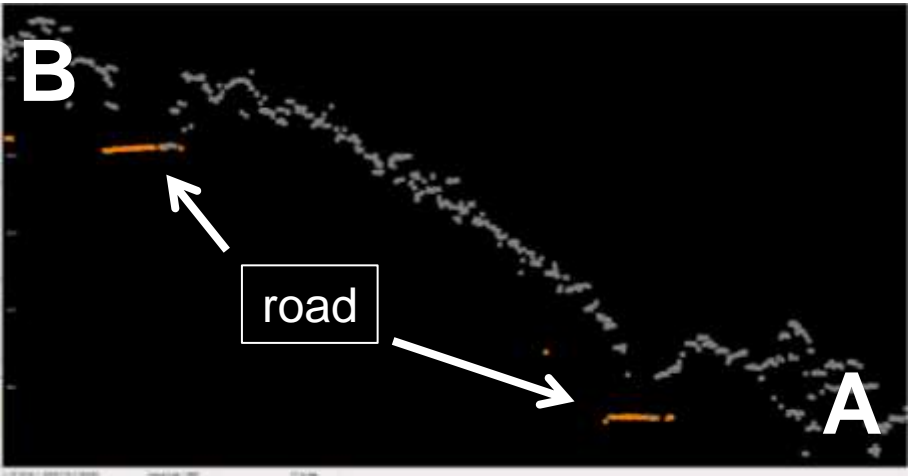
■ Different slope direction with different cloud density

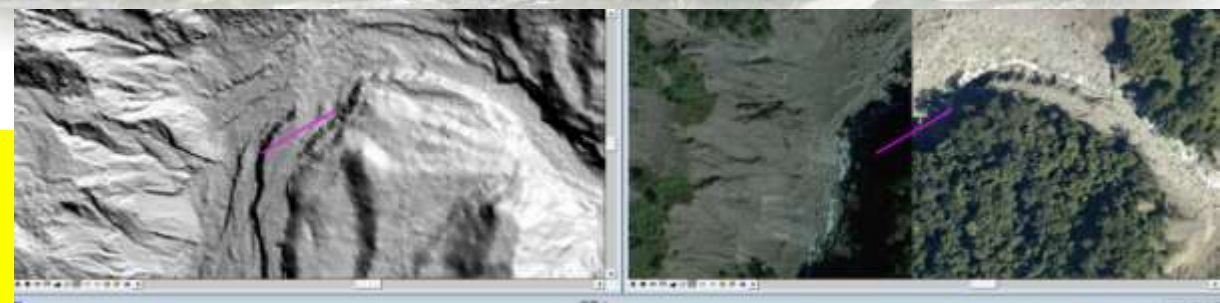
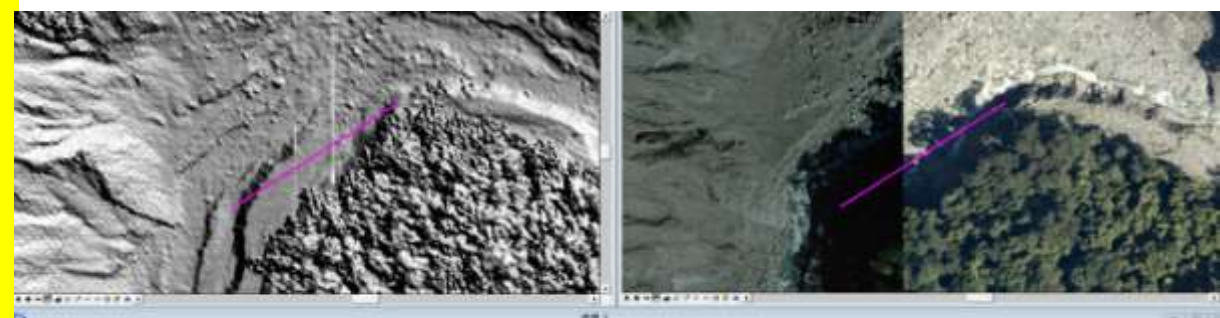
Boundary can't adjust owing to:

Topographic features changed by **natural** or **man-induced activities** from different year's surveying

Adjust the boundary between two map-sheets

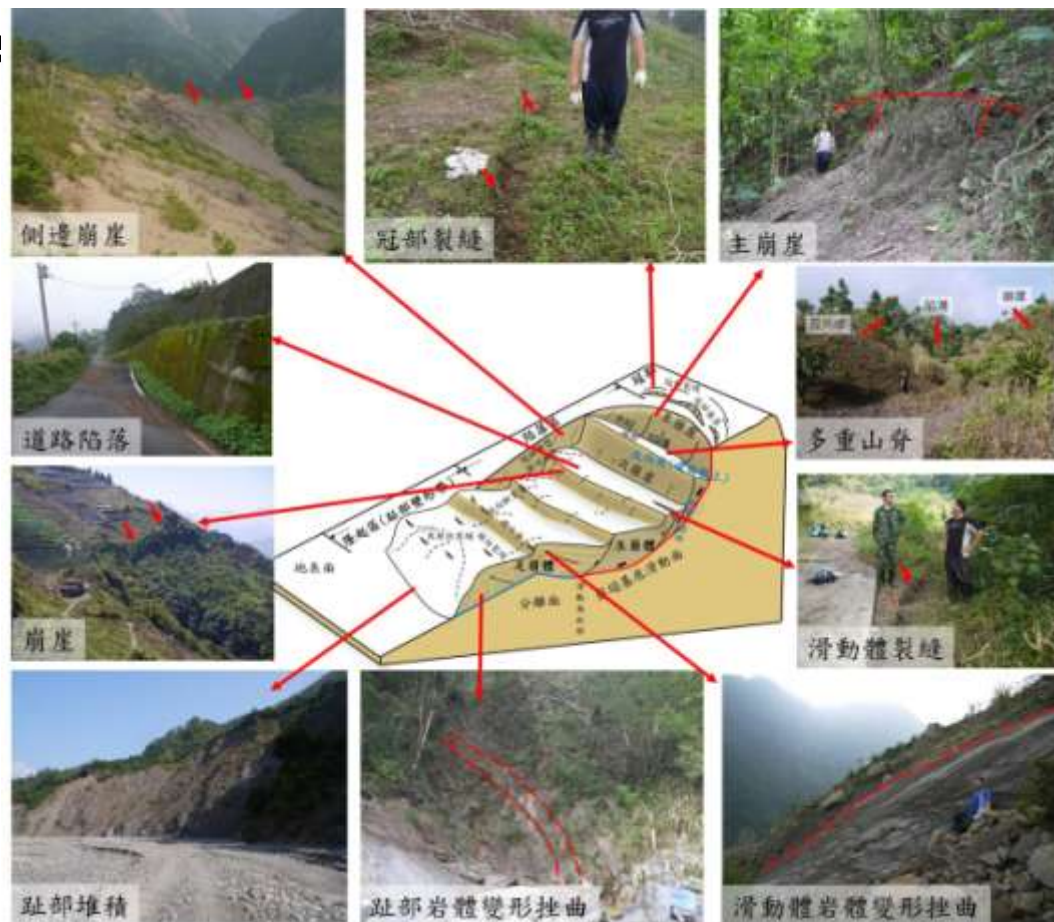
Topographic features of the Large-scale Landslide

- ✓ Ridge with a gentle slope
- ✓ Scarp、reverse slope、fissures and tension cracks
- ✓ Double ridge
- ✓ Linear depression
- ✓ Slide-body
- ✓ The bulge at the toe
- ✓ Gully sidewall and gully headwall failures
- ✓ Bedrock creep
- ✓ Older landslides

(Lin modified from WP/WLI, 1993)

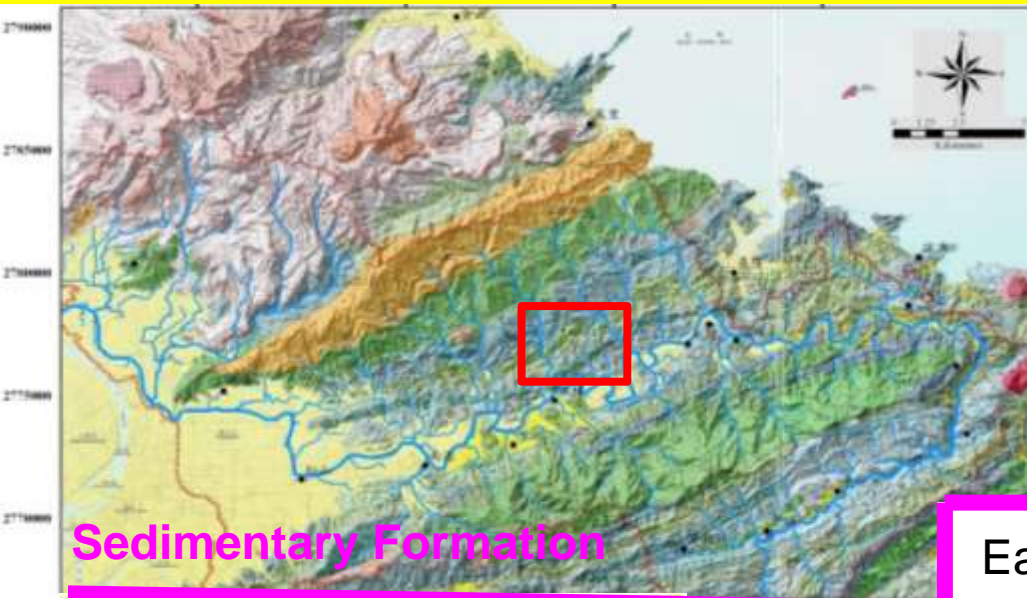
Detailed geological mapping – The rock units & bedding plane analyzed on the northern bank of Keelung River

Sedimentary Formation

Easily identify the rock units

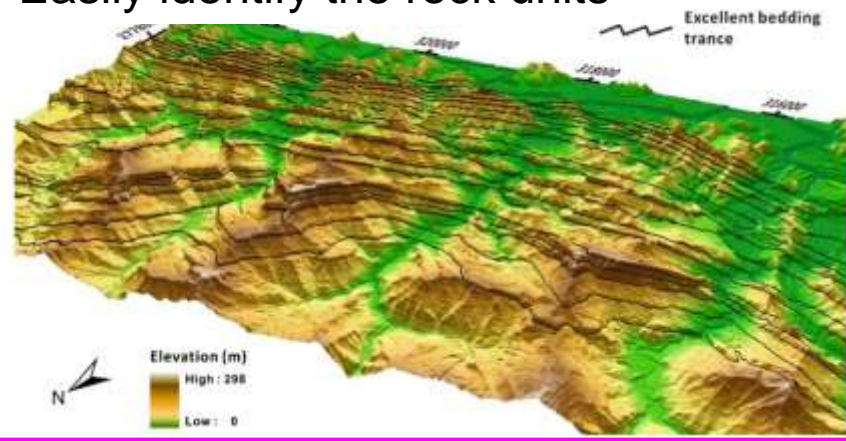
Easily identify the dip-slope

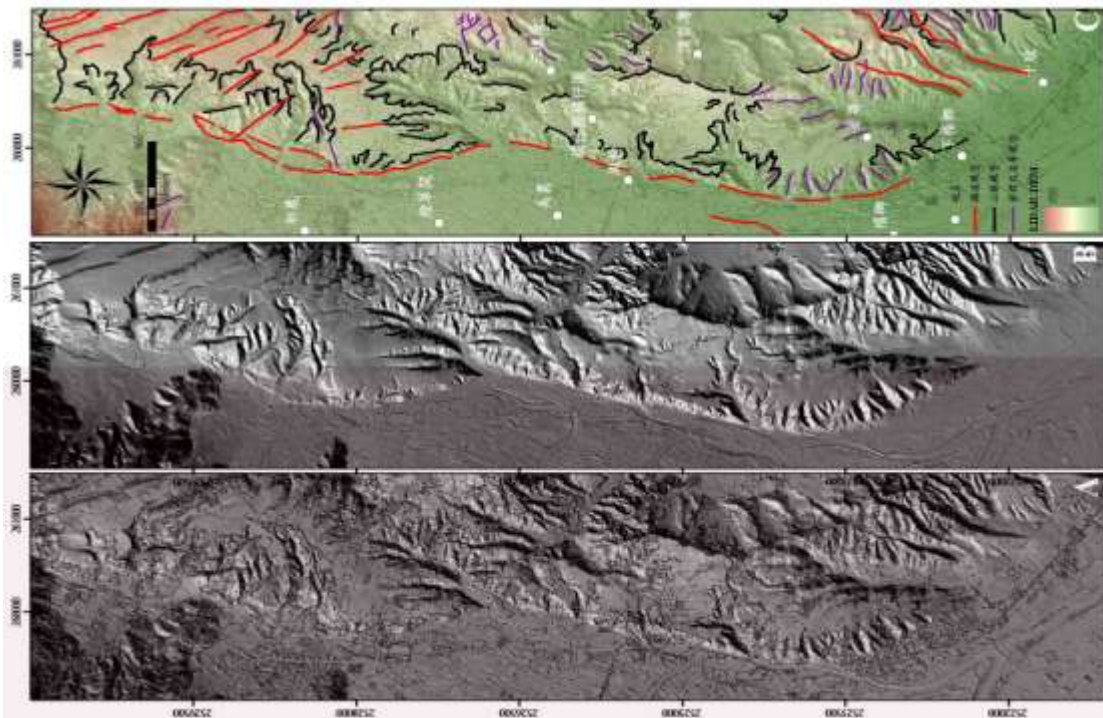
The detail structural characteristics of a fault analyzed by 3D anaglyph images
